UNITED STATES ENVIRONMENTAL PROTECTION AGENCY

INSTALLATION NAME: Arcelor Mittal Burns Harbor, LLC

DATE OF RCRA INSPECTION: June 13, 14, 15, 20, 27 - 30, 2011

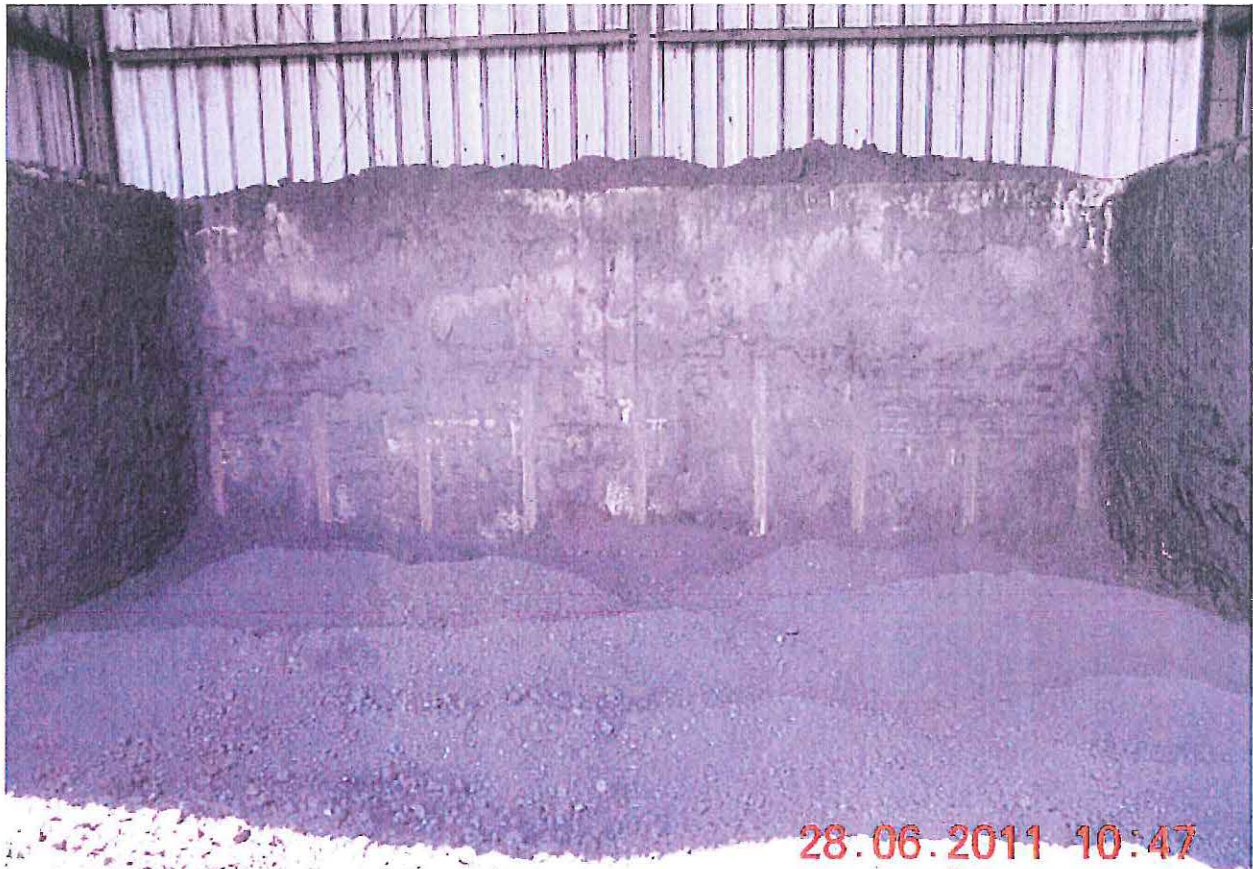
Description: Photograph 4: Three-sided building where clean up from spills are taken for storage. The floor is lined with coke fines. A vacuum truck or front end loader places the spilled material into the building for storage until the material is recycled into the coke production system. Facing W.

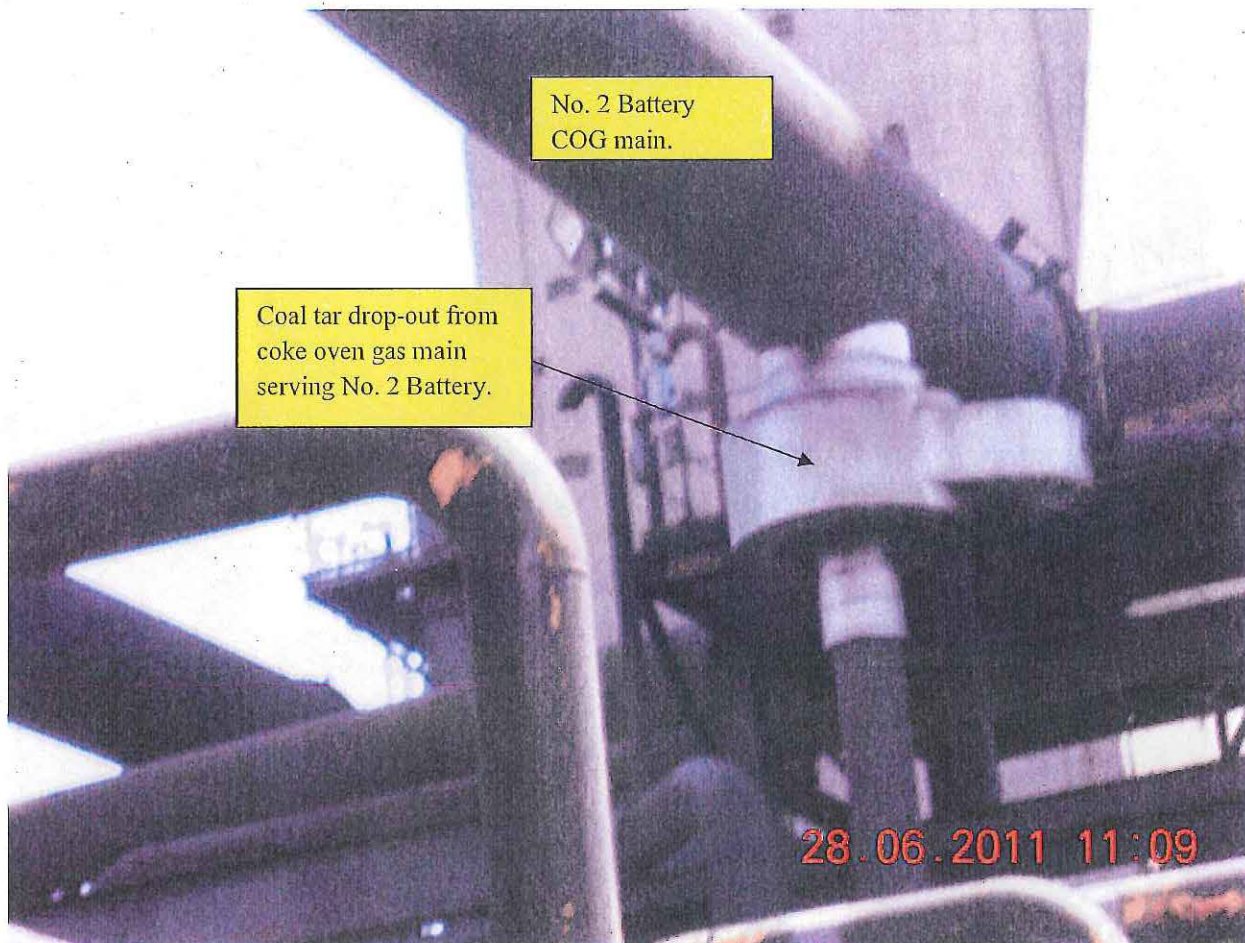
Facility: Arcelor Mittal, IND003913423
Location: 250 West US Highway 12, Burns Harbor, Indiana
Date: June 28, 2011, 11:09 a.m.
Photographer: Robert Dean Smith, LPG
Camera: Nikon Coolpix, 12.0 megapixels
Description: Photograph 8: Battery Number 2 piping. Coal tar is transported within the pipe indentified by the arrow. Tar drops out of the pipe at the silver attachment identified by the arrow. Facing N/NE

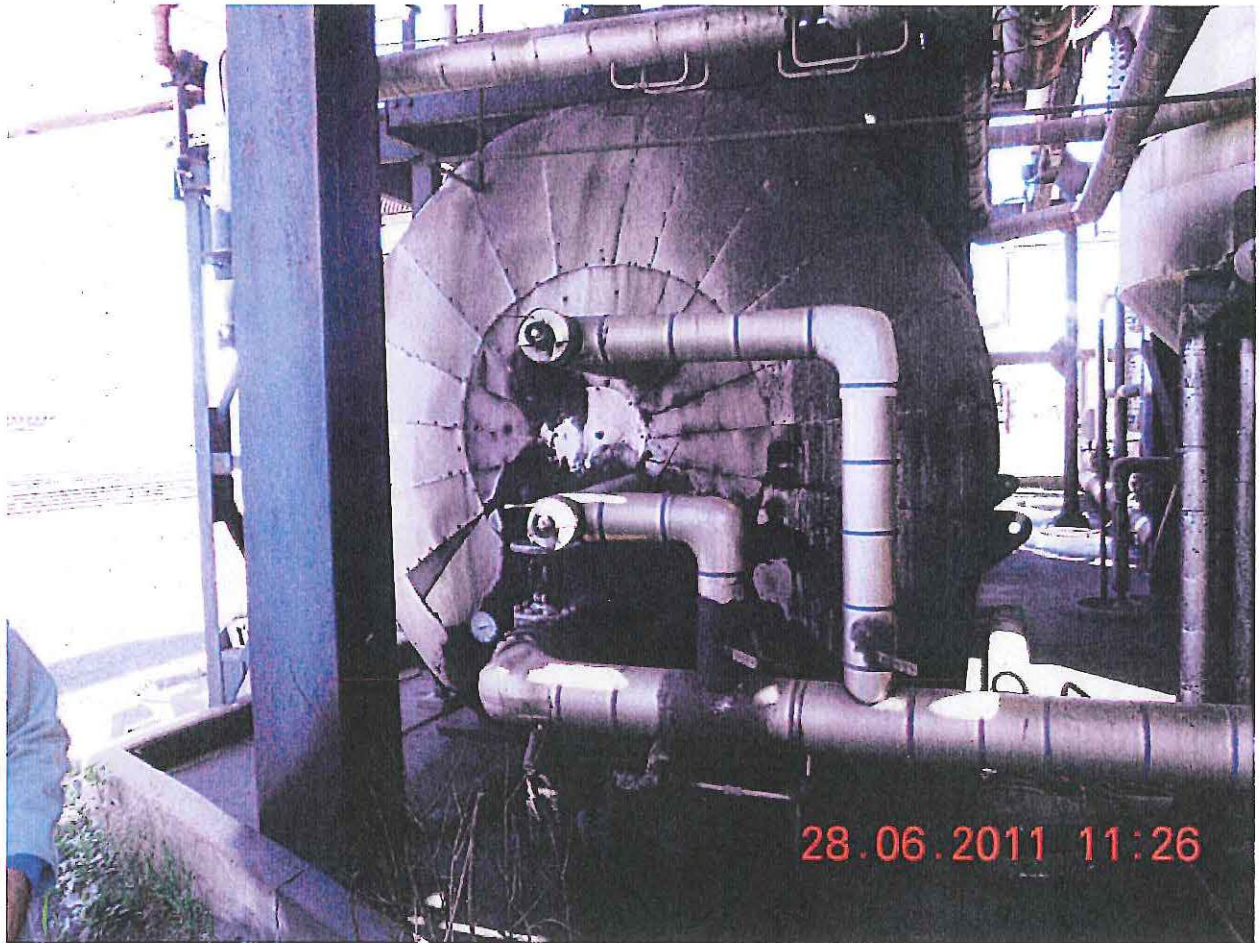
Facility: Arcelor Mittal, IND003913423
Location: 250 West US Highway 12, Burns Harbor, Indiana
Date: June 28, 2011, 11:24 a.m.
Photographer: Robert Dean Smith, LPG
Camera: Nikon Coolpix, 12.0 megapixels
Description: Photograph 10: Close up of muck oil tank. Sludge/dripping can be seen on the floor of the secondary containment. Facing W

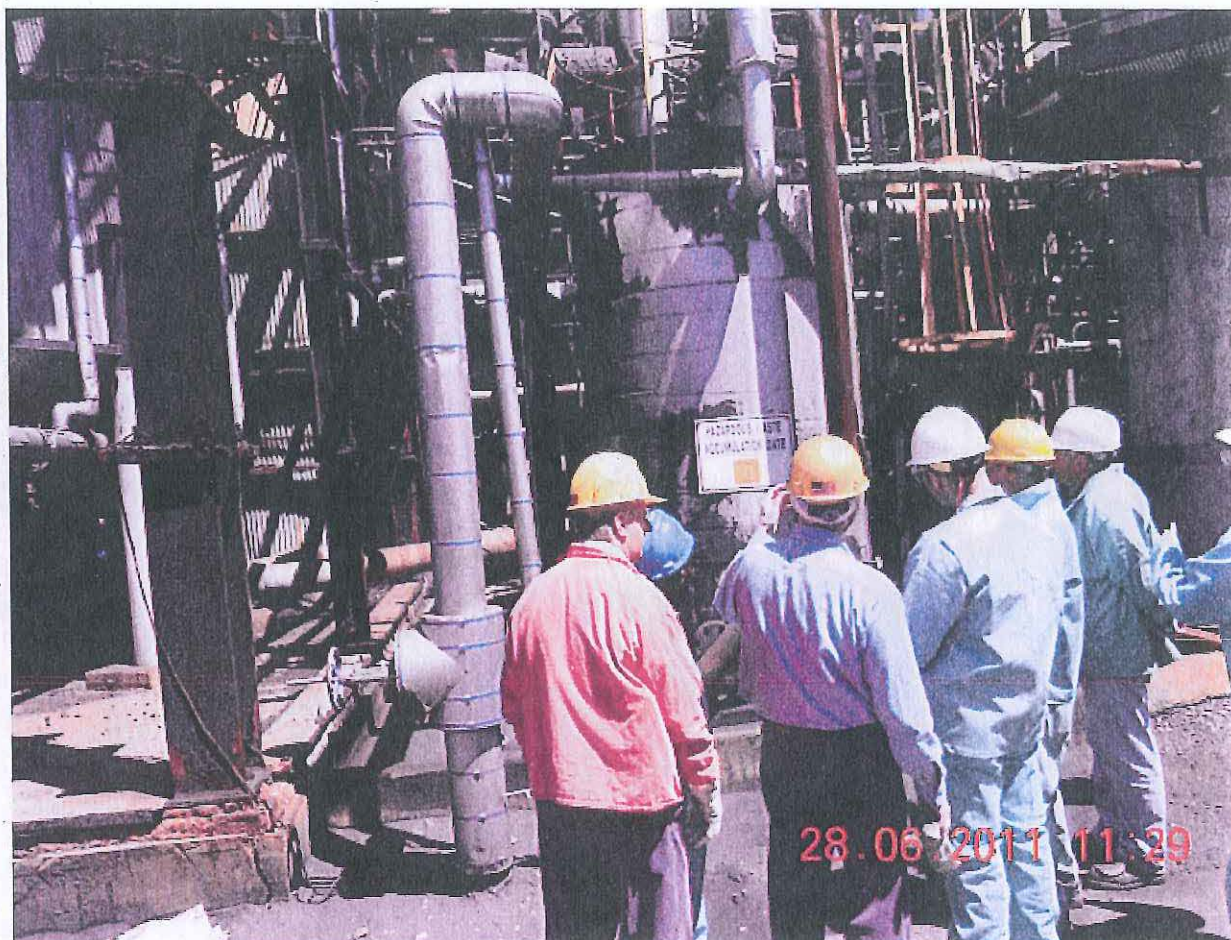
Facility: Arcelor Mittal, IND003913423
Location: 250 West US Highway 12, Burns Harbor, Indiana
Date: June 28, 2011, 11:26 a.m.
Photographer: Robert Dean Smith, LPG
Camera: Nikon Coolpix, 12.0 megapixels
Description: Photograph 11: End of muck oil tank. There are three pipes on the end of this tank. The highest pipe decants the higher quality of oil. Facing West.

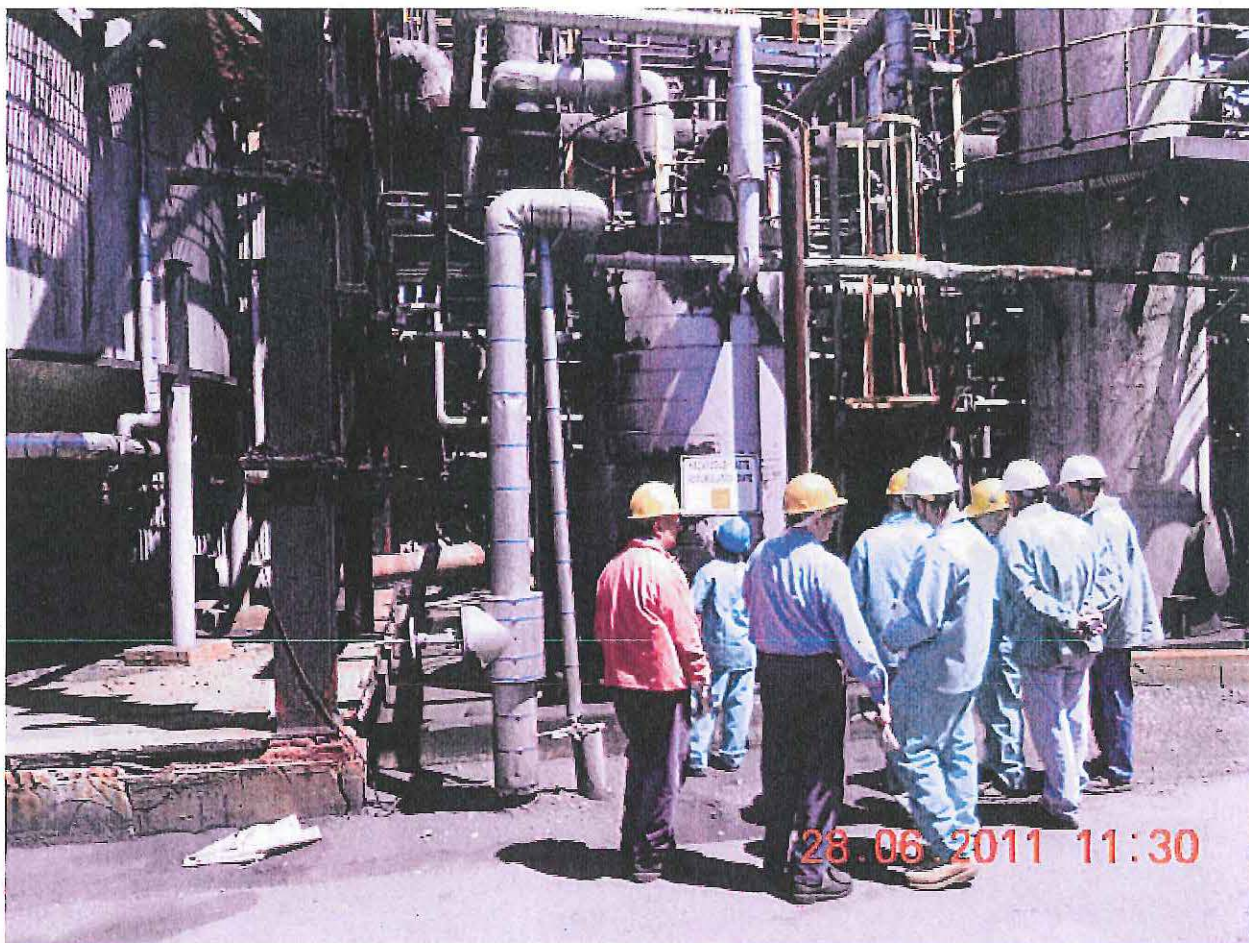
Facility: Arcelor Mittal, IND003913423
Location: 250 West US Highway 12, Burns Harbor, Indiana
Date: June 28, 2011, 11:29 a.m.
Photographer: Robert Dean Smith, LPG
Camera: Nikon Coolpix, 12.0 megapixels
Description: Photograph 12: Naphthalene Scrubber Muck Oil Tank. Facing N.

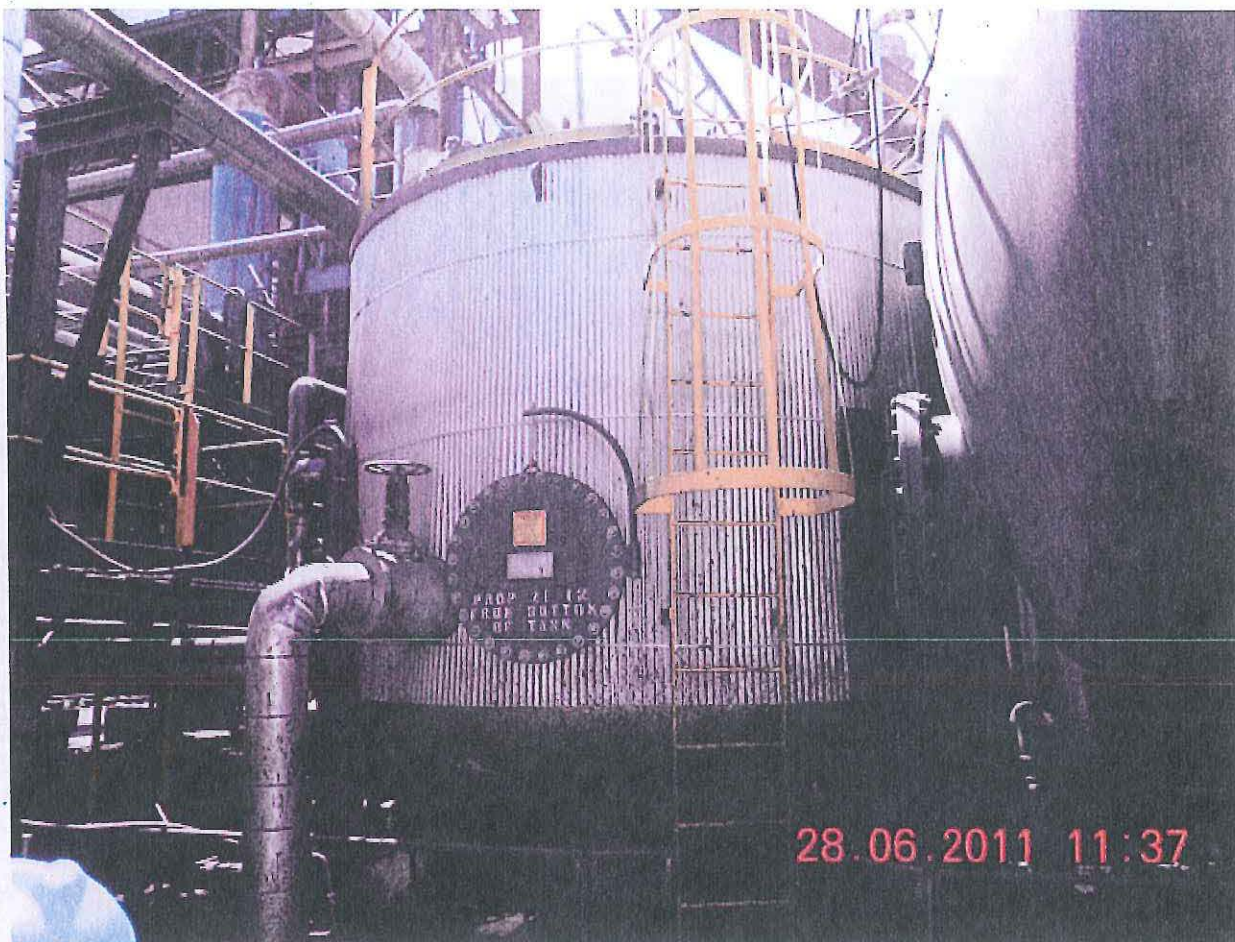
Facility: Arcelor Mittal, IND003913423
Location: 250 West US Highway 12, Burns Harbor, Indiana
Date: June 28, 2011, 11:30 a.m.
Photographer: Robert Dean Smith, LPG
Camera: Nikon Coolpix, 12.0 megapixels
Description: Photograph 15: Hazardous waste sticker affixed onto the Naphthalene Scrubber Muck Tank. Facing N.

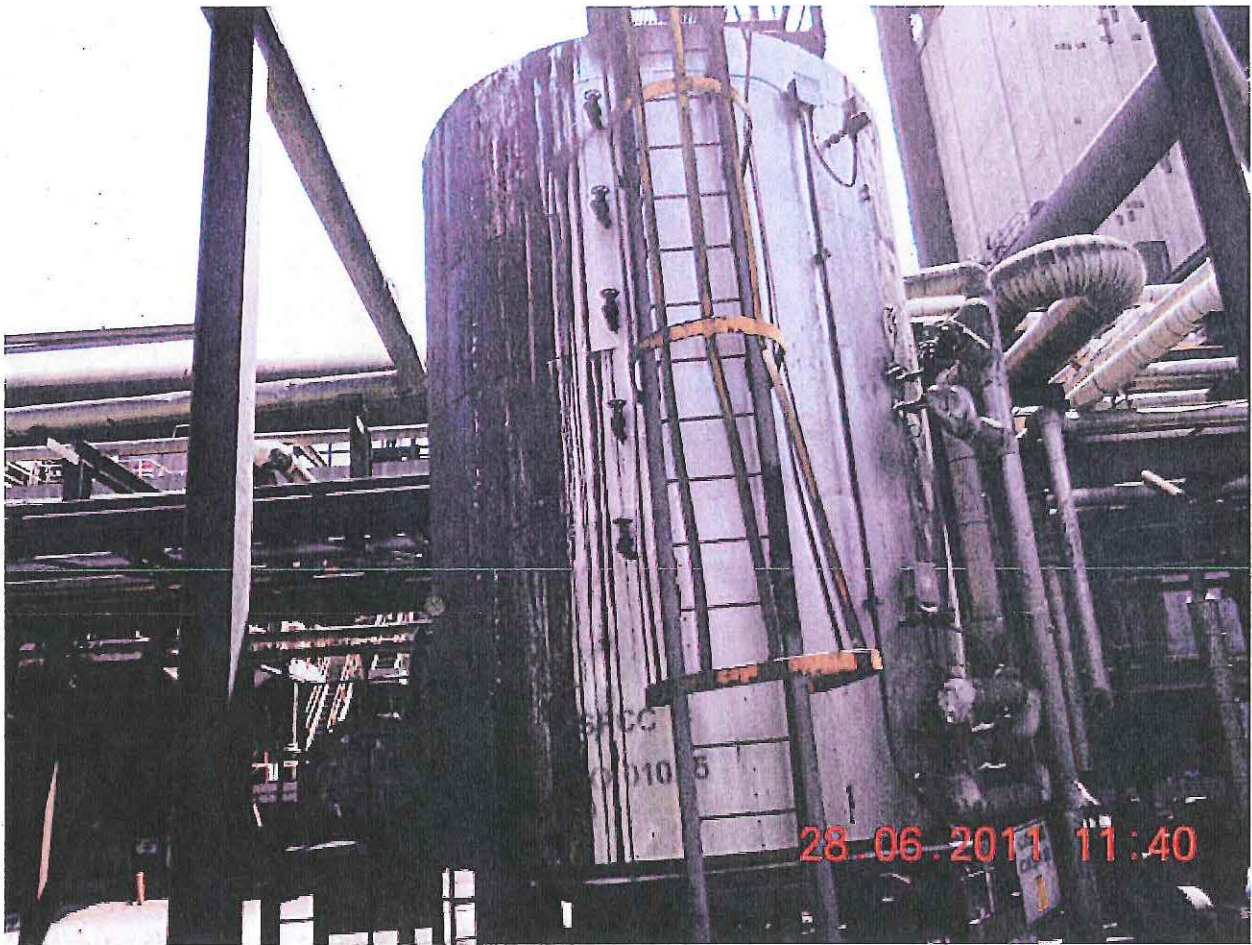
Facility: Arcelor Mittal, IND003913423
Location: 250 West US Highway 12, Burns Harbor, Indiana
Date: June 28, 2011, 11:37 a.m.
Photographer: Robert Dean Smith, LPG
Camera: Nikon Coolpix, 12.0 megapixels
Description: Photograph 16: Sludge mixer tank. Facing S/SE

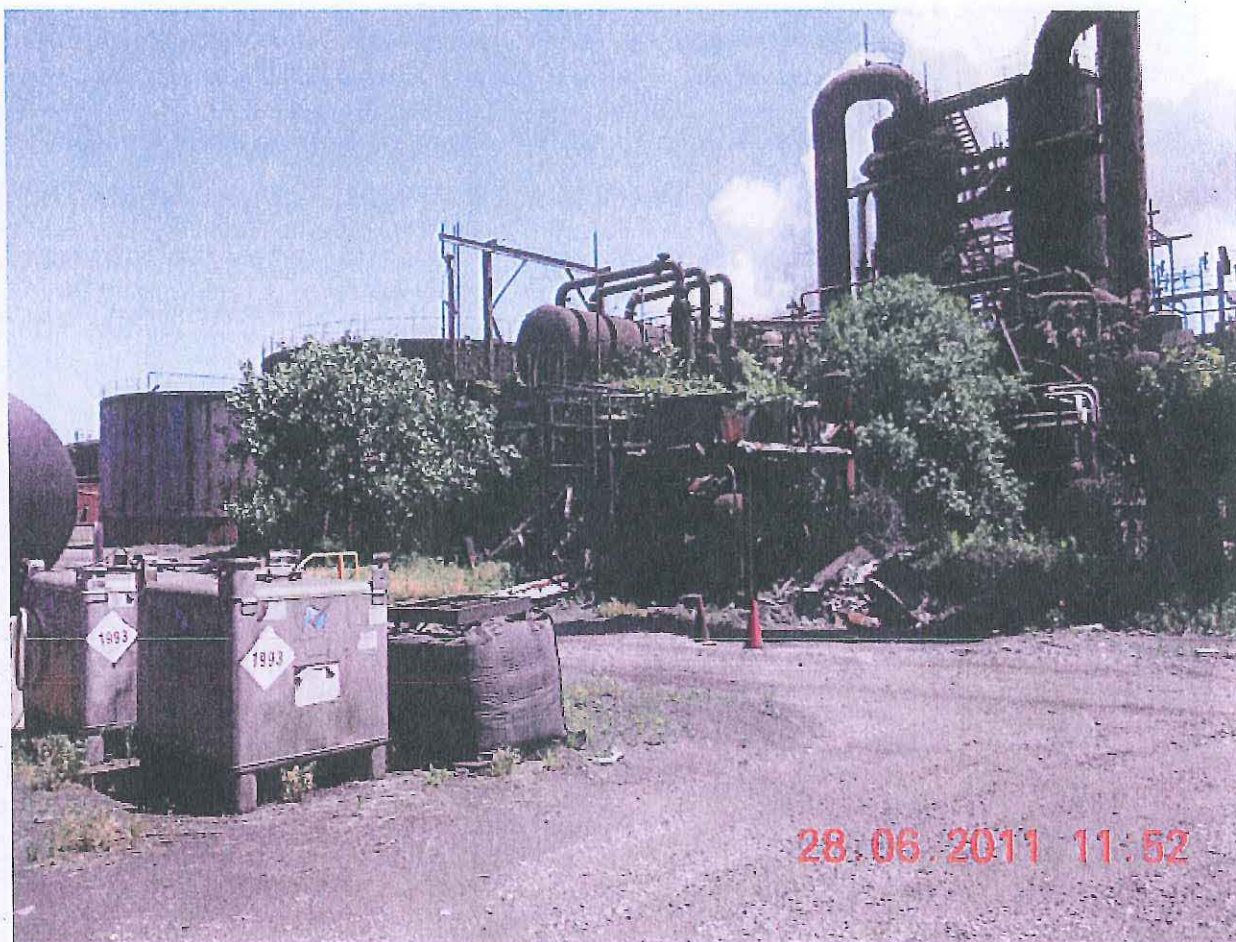
Facility: Arcelor Mittal, IND003913423
Location: 250 West US Highway 12, Burns Harbor, Indiana
Date: June 26, 2011, 11:40 a.m.
Photographer: Robert Dean Smith, LPG
Camera: Nikon Coolpix, 12.0 megapixels
Description: Photograph 17: Empty tank, out of service. Facing E.

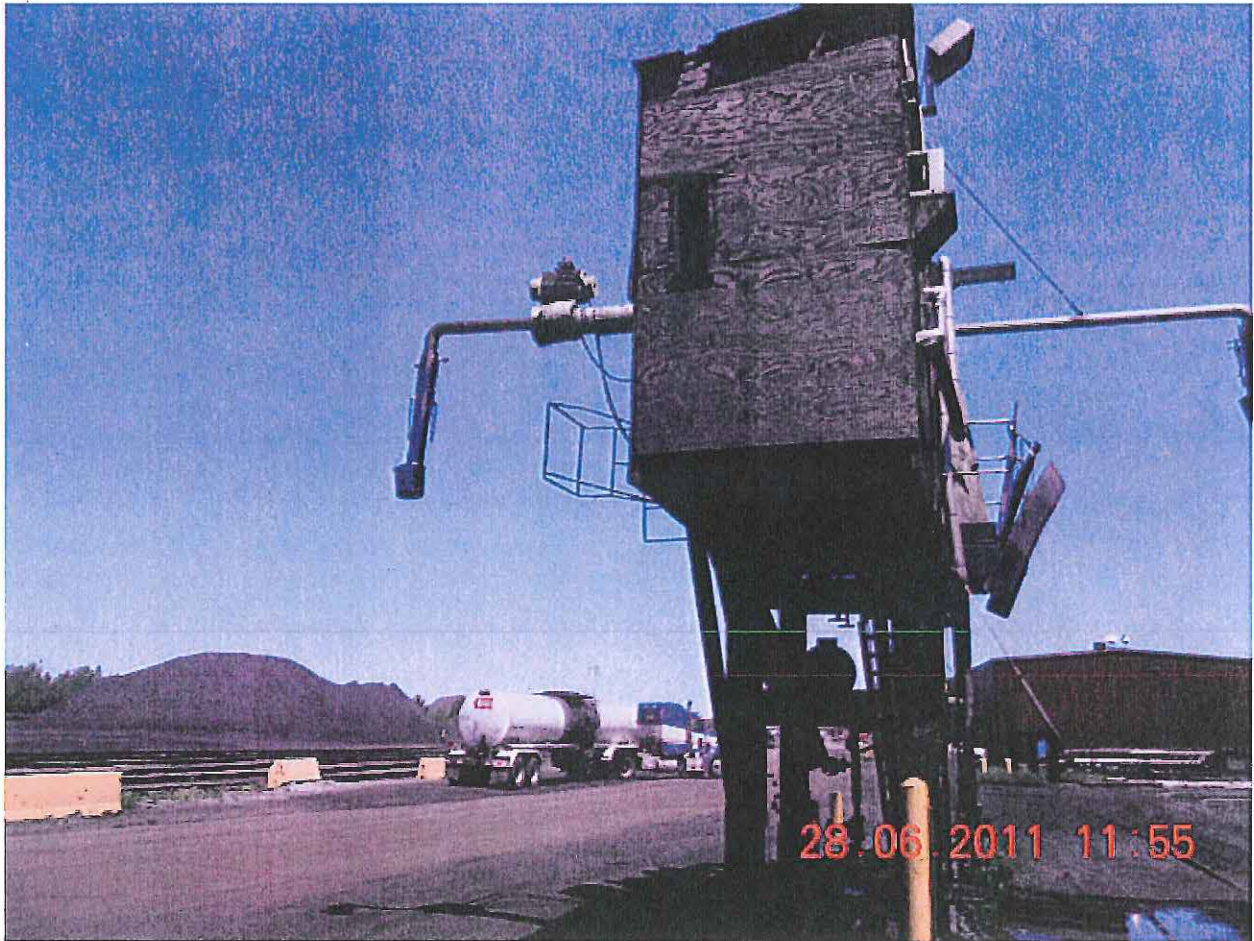
Facility: Arcelor Mittal, IND003913423
Location: 250 West US Highway 12, Burns Harbor, Indiana
Date: June 28, 2011, 11:52 a.m.
Photographer: Robert Dean Smith, LPG
Camera: Nikon Coolpix, 12.0 megapixels
Description: Photograph 18: Abandoned desulfurization system. Facing NE.

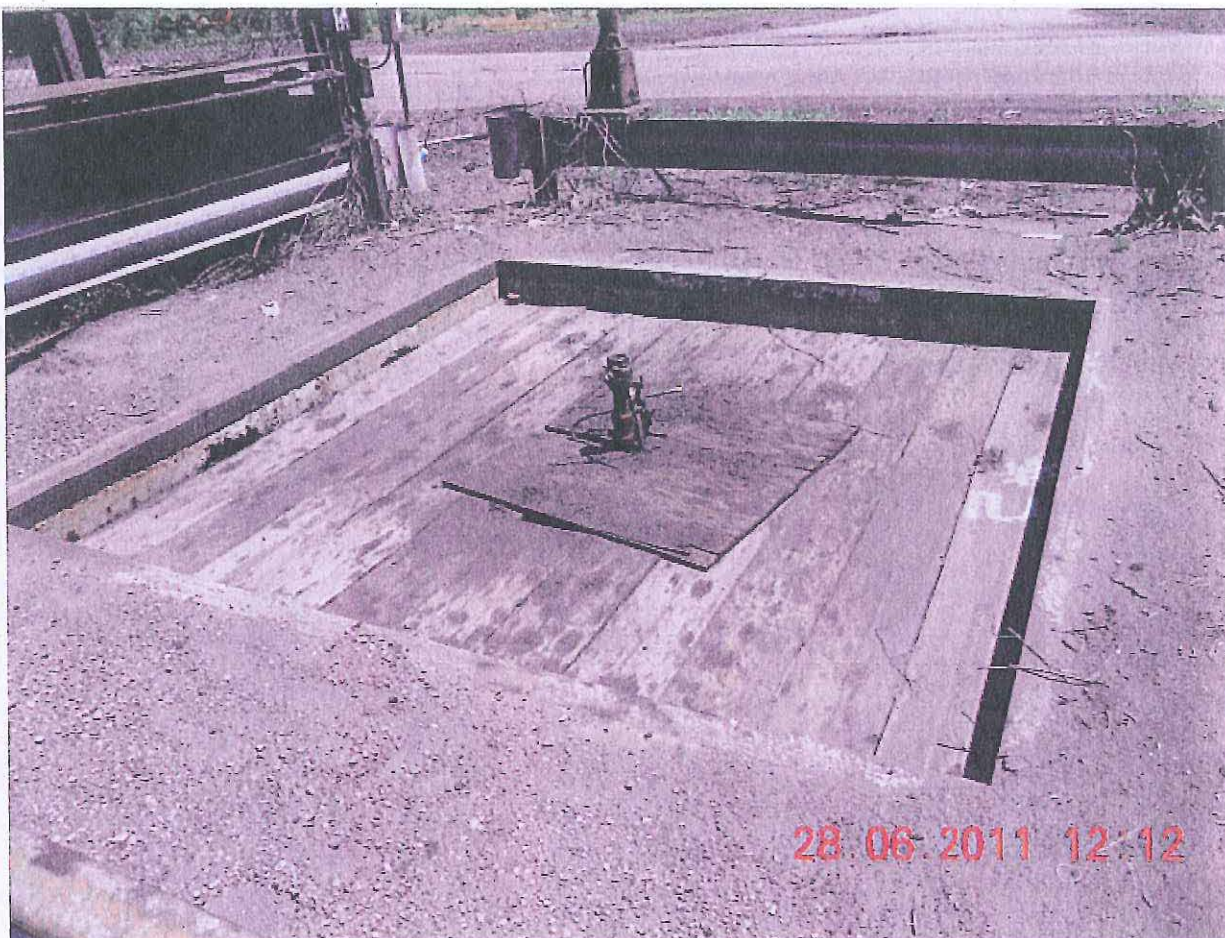
Facility: Arcelor Mittal, IND003913423
Location: 250 West US Highway 12, Burns Harbor, Indiana
Date: June 28, 2011, 12:07 p.m.
Photographer: Robert Dean Smith, LPG
Camera: Nikon Coolpix, 12.0 megapixels
Description: Photograph 21: Underground injection well. Facing NE.

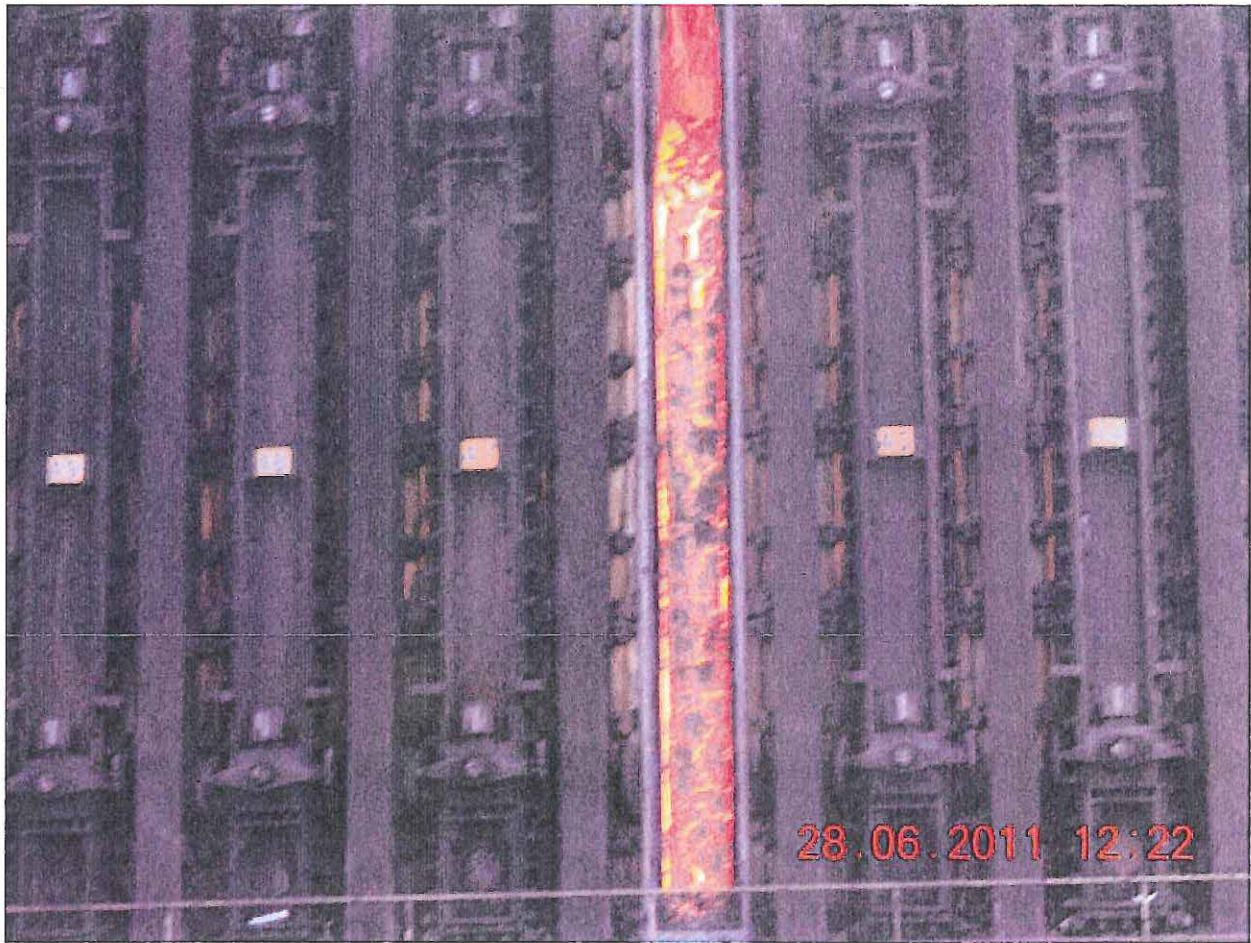
Facility: Arcelor Mittal, IND003913423
Location: 250 West US Highway 12, Burns Harbor, Indiana
Date: June 28, 2011, 12:12 p.m.
Photographer: Robert Dean Smith, LPG
Camera: Nikon Coolpix, 12.0 megapixels
Description: Photograph 22: Another photograph of the underground injection well.

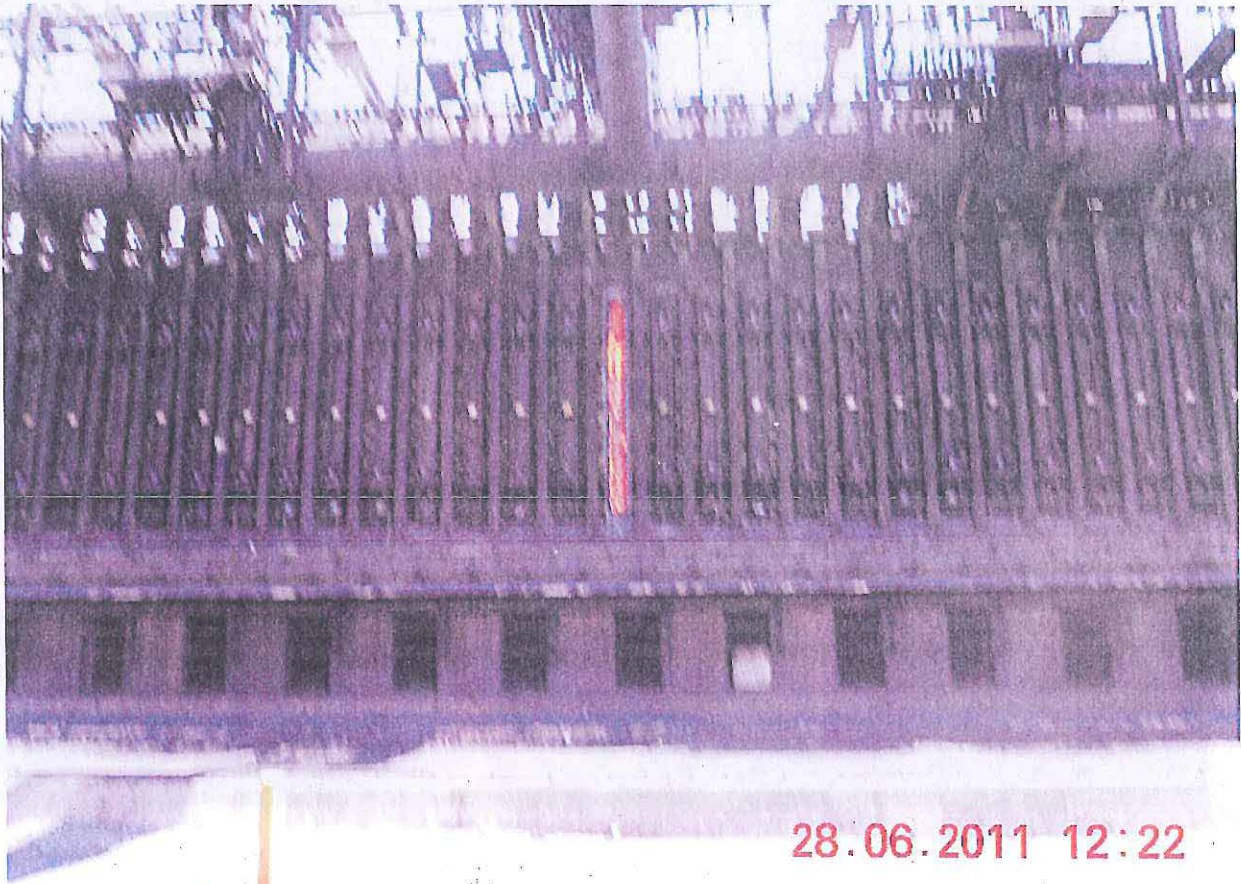
Facility: Arcelor Mittal, IND003913423
Location: 250 West US Highway 12, Burns Harbor, Indiana
Date: June 28, 2011, 12:22 p.m.
Photographer: Robert Dean Smith, LPG
Camera: Nikon Coolpix, 12.0 megapixels
Description: Photograph 23: Coke Battery Number 2, Cell number 46. Facing E.

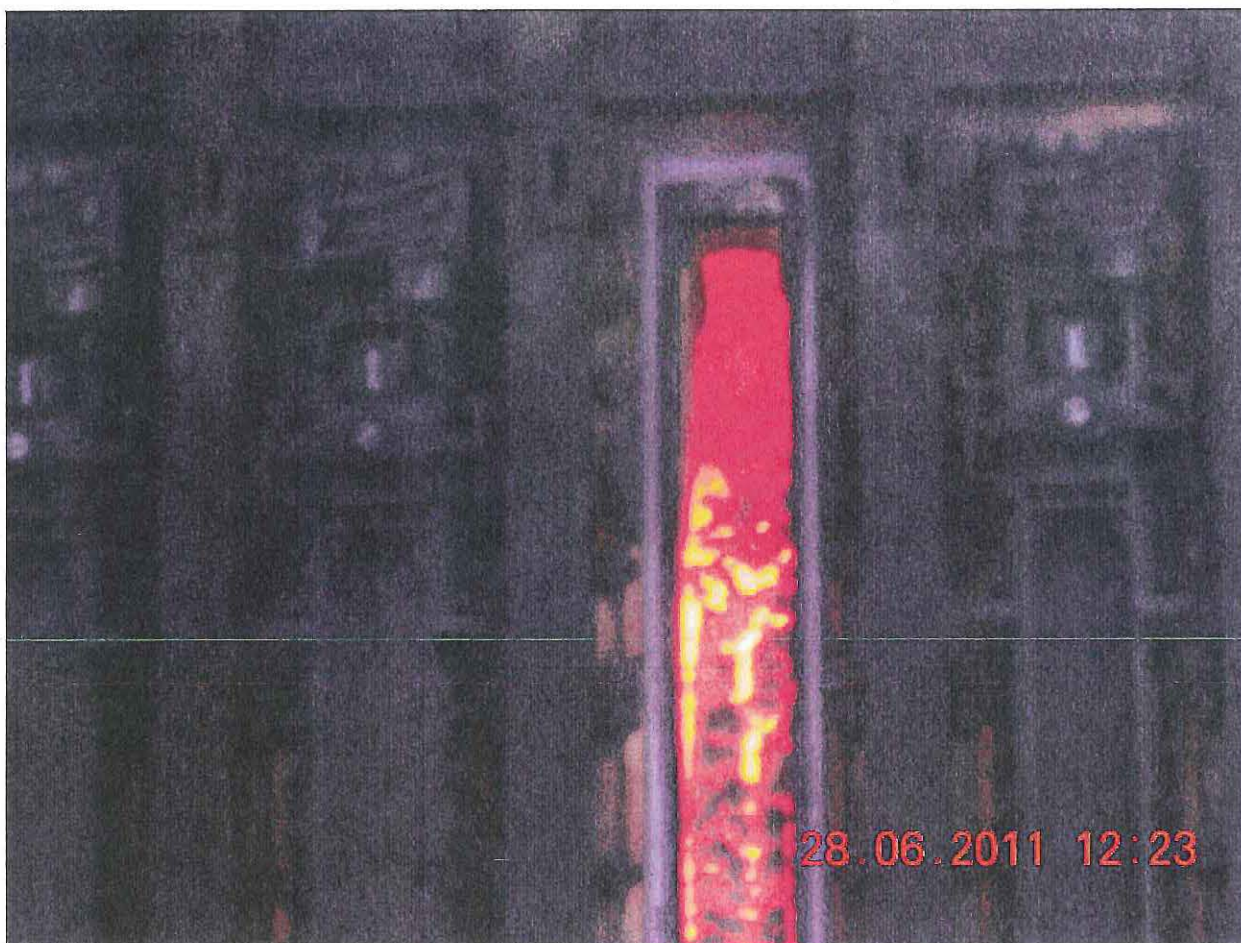
Facility: Arcelor Mittal, IND003913423
Location: 250 West US Highway 12, Burns Harbor, Indiana
Date: June 28, 2011, 12:22 p.m.
Photographer: Robert Dean Smith, LPG
Camera: Nikon Coolpix, 12.0 megapixels
Description: Photograph 24: Coke Battery Number 2, Cell number 46. Facing E.

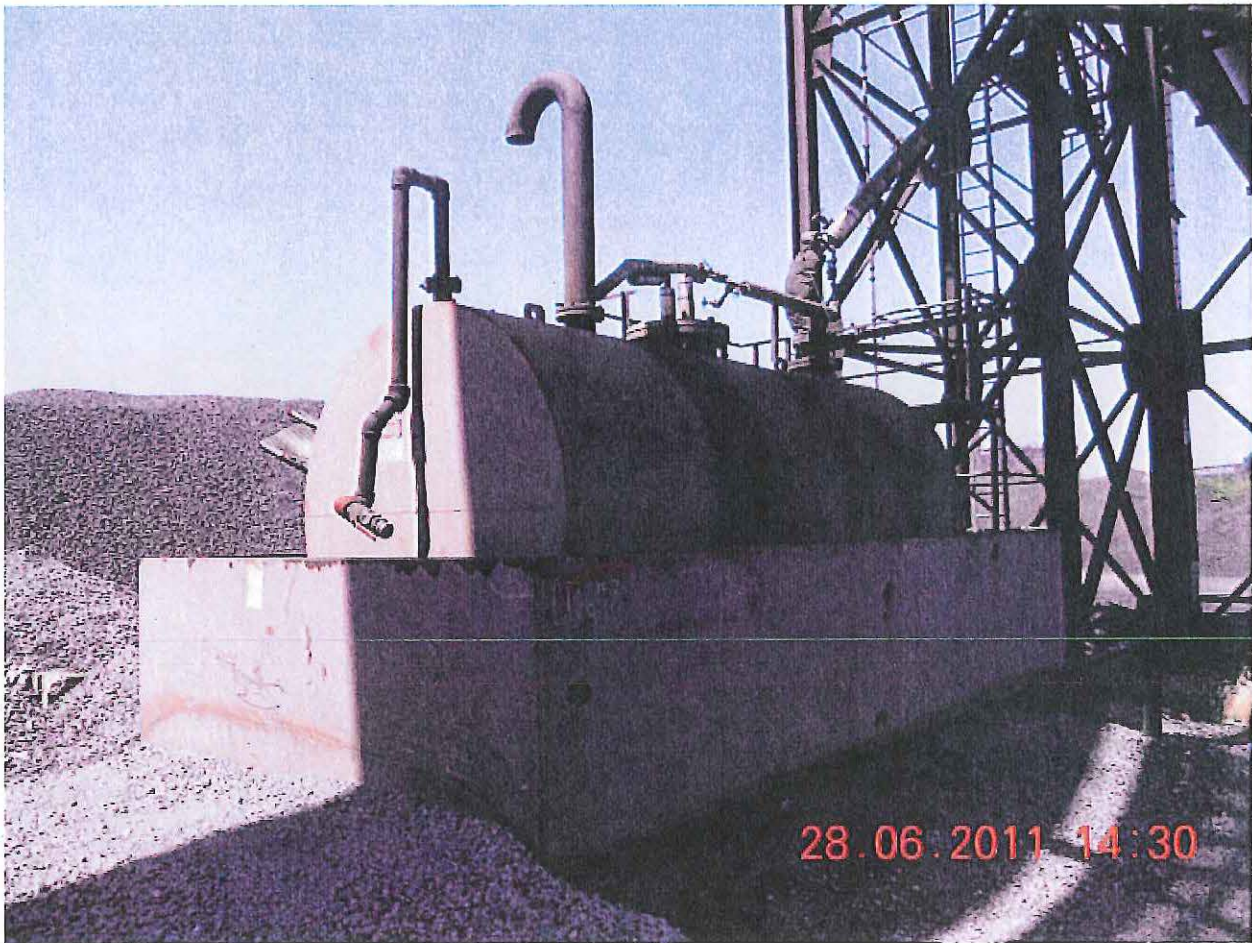
Facility: Arcelor Mittal, IND003913423
Location: 250 West US Highway 12, Burns Harbor, Indiana
Date: June 28, 2011, 2:29 p.m.
Photographer: Robert Dean Smith, LPG
Camera: Nikon Coolpix, 12.0 megapixels
Description: Photograph 26: Coke Over Gas Condensate Tank showing secondary containment located north of the coke plant and found beneath the coke over gas line. The tank is labeled and marked. Facing N.

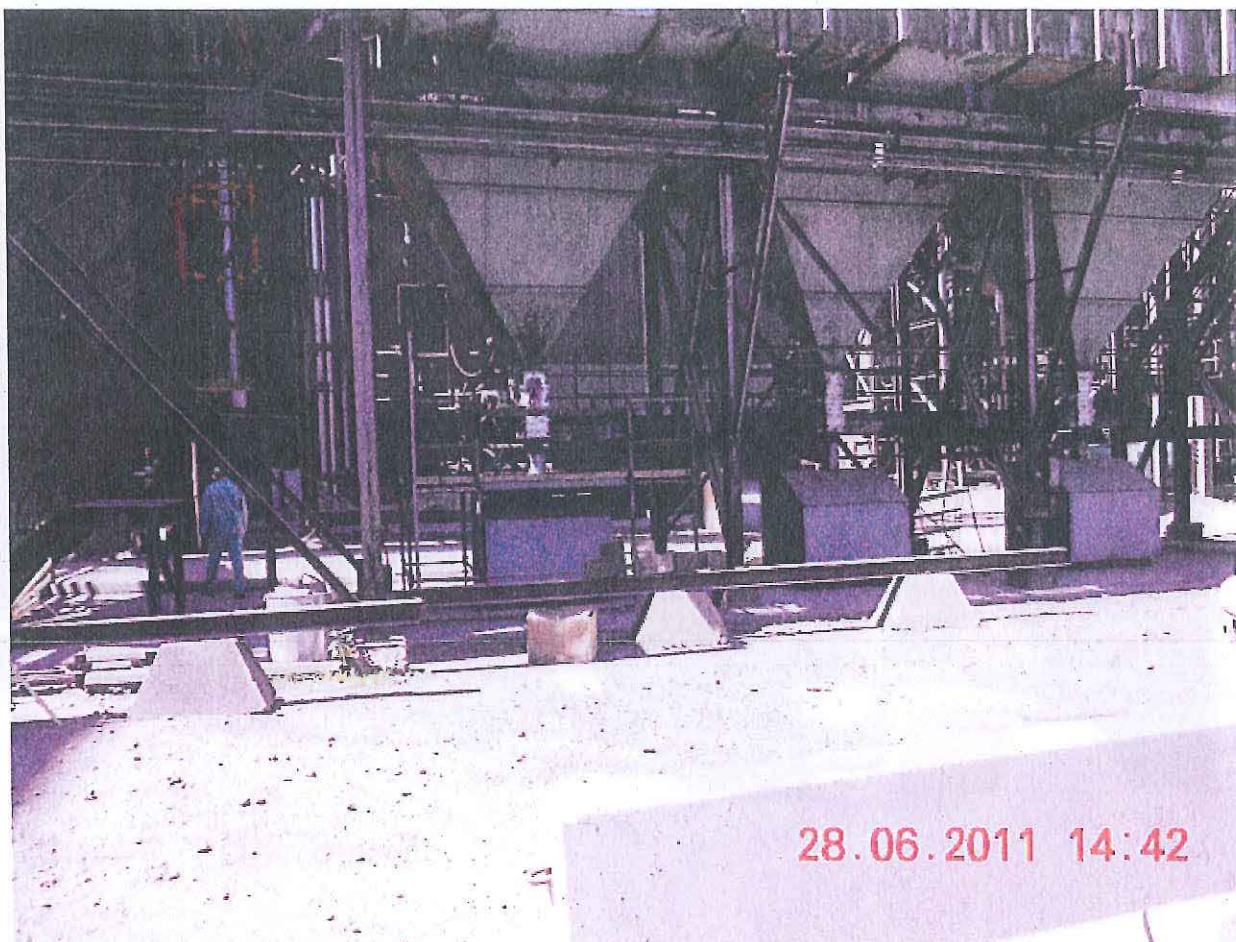
- Roll off box, operated under vacuum, collects the LTS dust, a hazardous waste (photographs 28 – 34). Photograph 29 shows a release of hazardous waste dust on the right side of the photograph. Due to the nature of the inspection, this release was actually identified two days later when EPA re-visited the site, specifically looking for releases of hazardous waste dust.

Facility: Arcelor Mittal, IND003913423
Location: 250 West US Highway 12, Burns Harbor, Indiana
Date: June 28, 2011, 2:39 p.m.
Photographer: Robert Dean Smith, LPG
Camera: Nikon Coolpix, 12.0 megapixels
Description: Photograph 29: Vacuum operated roll-off box used to collect hazardous waste dust from the bag houses located at the back end of LTS #4. A small pile of possible hazardous waste dust can be seen on right side of the roll off box. This pile of dust was actually discovered two days later when EPA returned to this area for a second inspection. It is seen clearly that the pile existed at the time of this photograph. The dust is brown or rust in color. The pile of released dust can be seen in later photographs. This vacuum roll-off box is located in the furnace area of the plant. This area is 30 degrees off of "plant north". The orientation is rotated 30 degrees to the west. Plant north is close to true north. The orientation of the vacuum roll-off box is close to NE-SW Facing E.

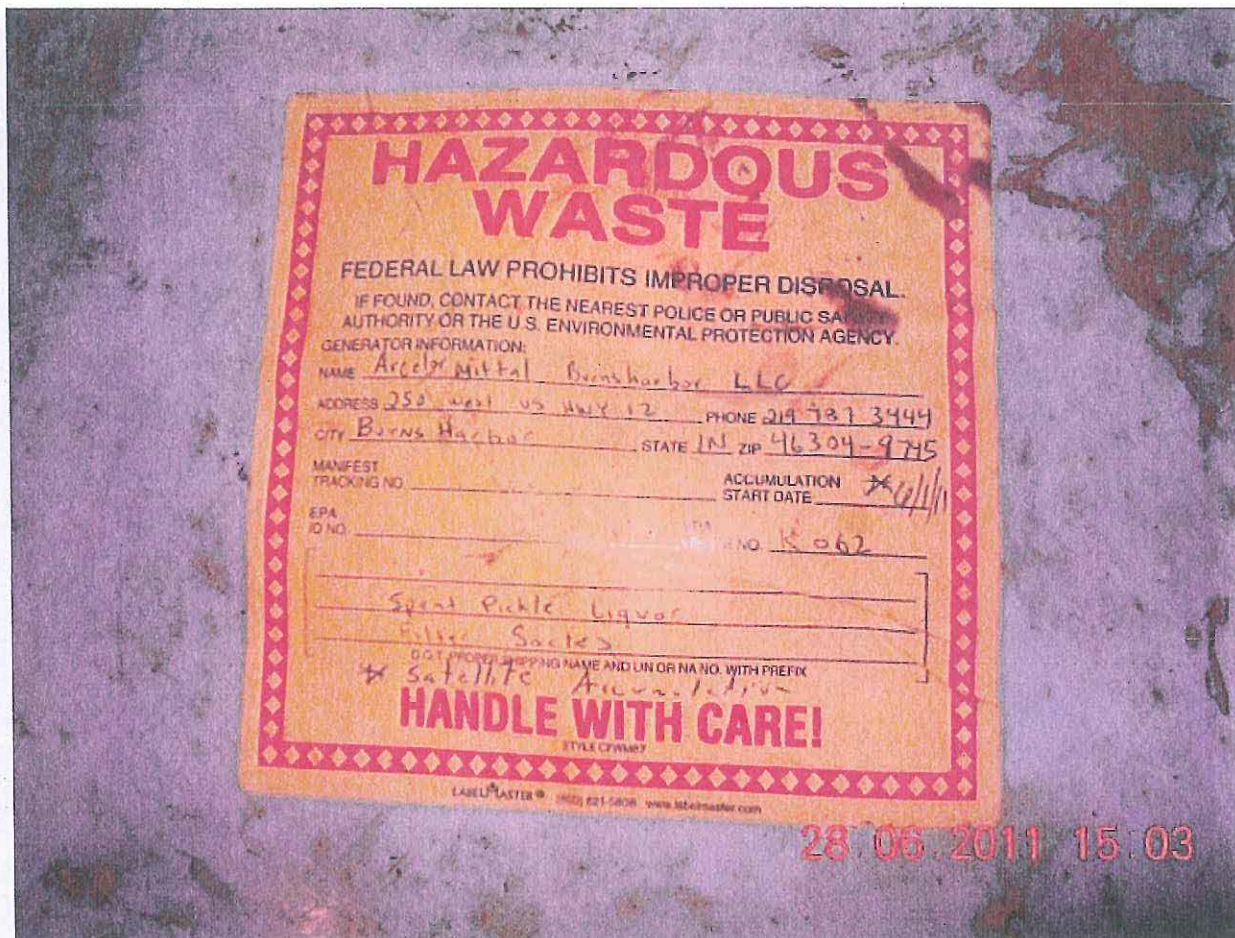
Facility: Arcelor Mittal, IND003913423
Location: 250 West US Highway 12, Burns Harbor, Indiana
Date: June 28, 2011, 2:50 p.m.
Photographer: Robert Dean Smith, LPG
Camera: Nikon Coolpix, 12.0 megapixels
Description: Photograph 33: Hazardous waste label for the hazardous waste roll off at the LTS #5 baghouse. Facing S.

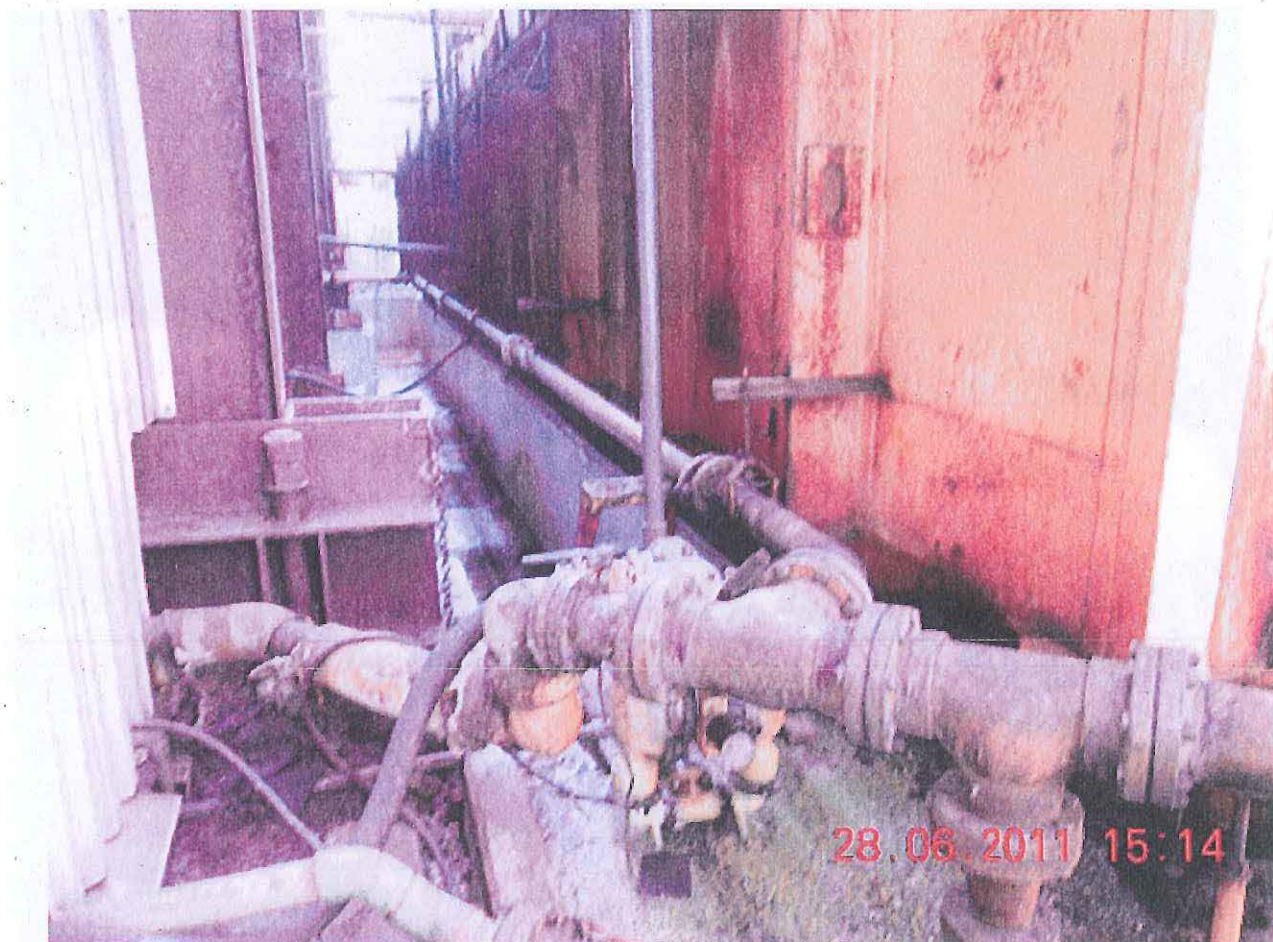
Facility: Arcelor Mittal, IND003913423
Location: 250 West US Highway 12, Burns Harbor, Indiana
Date: June 28, 2011, 3:09 p.m.
Photographer: Robert Dean Smith, LPG
Camera: Nikon Coolpix, 12.0 megapixels
Description: Photograph 37: Spent pickle liquor residue adjacent to the spent liquor tank. Facing W.

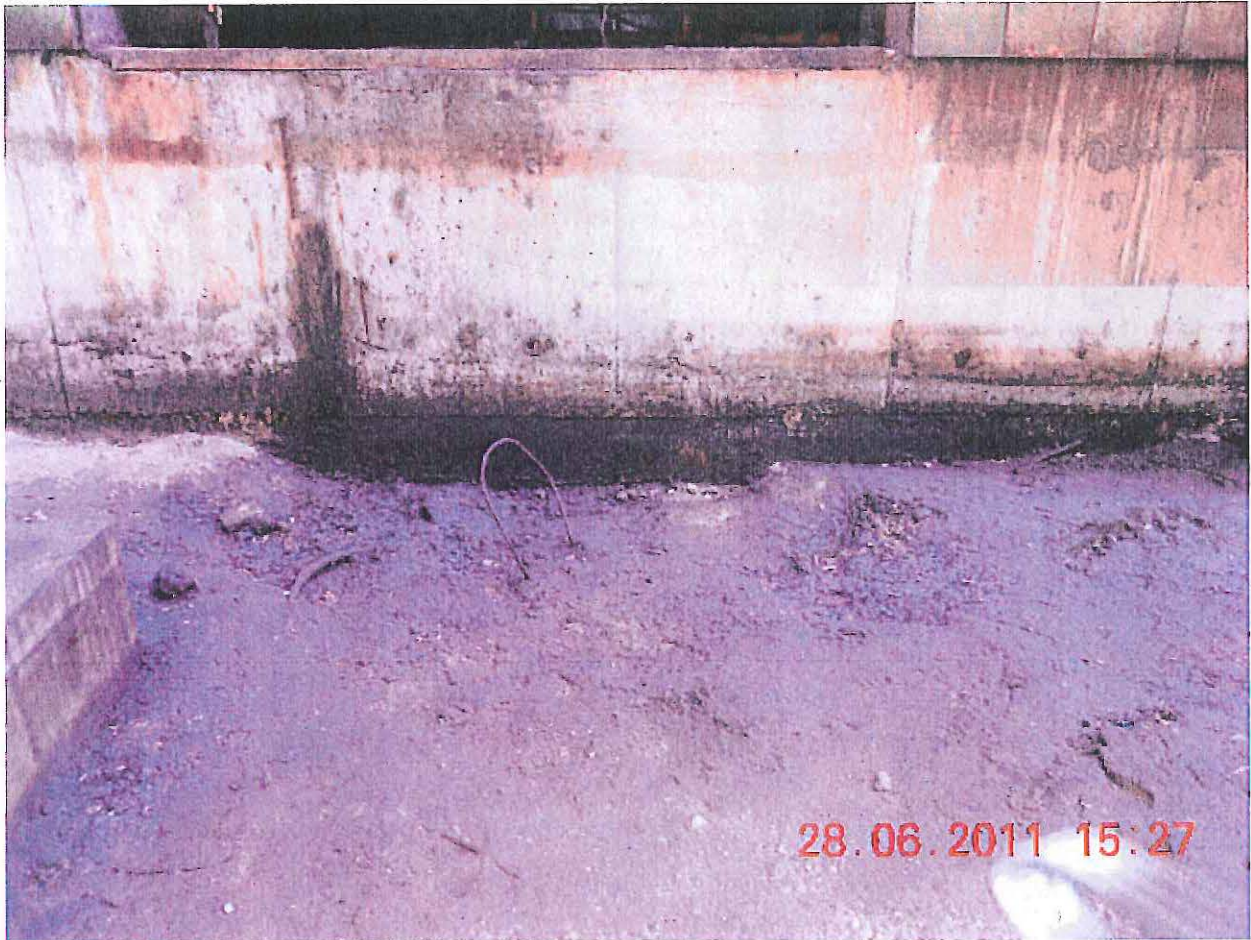
Facility: Arcelor Mittal, IND003913423
Location: 250 West US Highway 12, Burns Harbor, Indiana
Date: June 28, 3:20 p.m.
Photographer: Robert Dean Smith, LPG
Camera: Nikon Coolpix, 12.0 megapixels
Description: Photograph 40: Spent pickle liquor injection well number 2. Facing W.
